Planning and Heritage Management in a World Heritage Site. A case study

12NP0108 *Construction of additional car parking area to create a further 40 No. Parking bays.* Housesteads Visitor Centre, Haydon Bridge, Hexham, Northumberland NE47 6NN.

Applicant: Northumberland National Park Authority. LPA: Northumberland National Park Authority

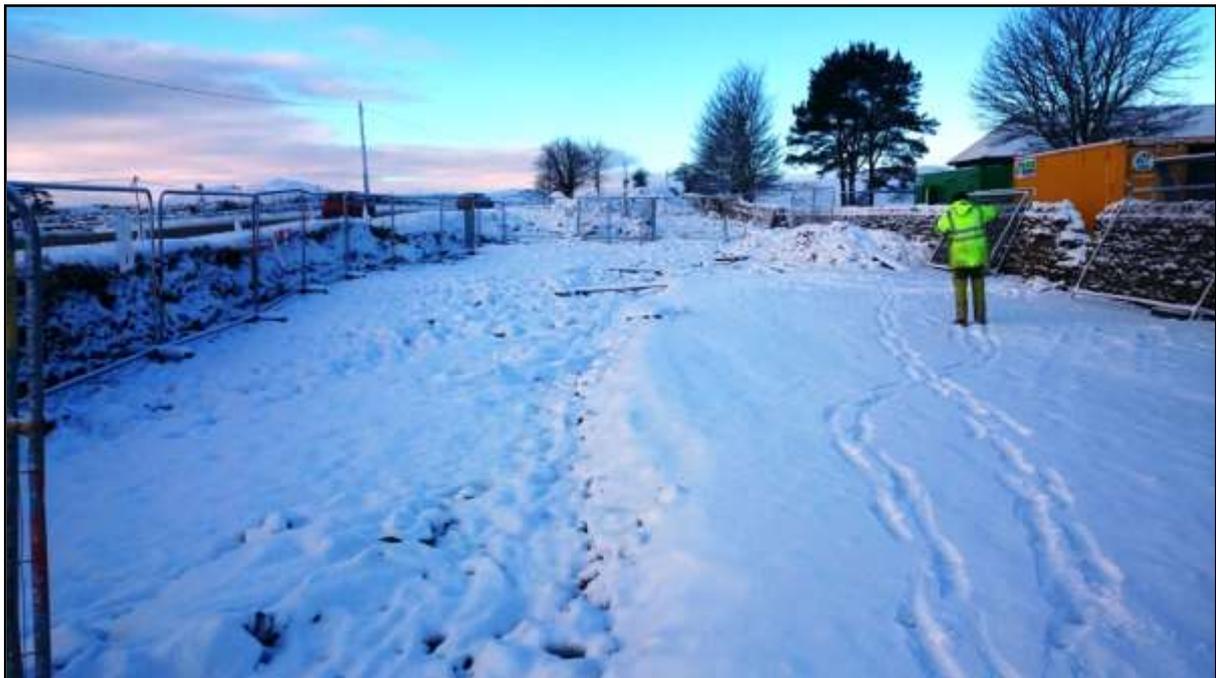
The morning of 15th February and conditions on site deteriorate

Owing to the time of year and location, the project was vulnerable to poor weather conditions. Wintry weather led to the effective postponement of detailed cleaning due to the presence of ice and snow on site. Once the ice had thawed this presented a problem of excessively wet conditions and water had to be pumped off site to allow any archaeological work to take place.

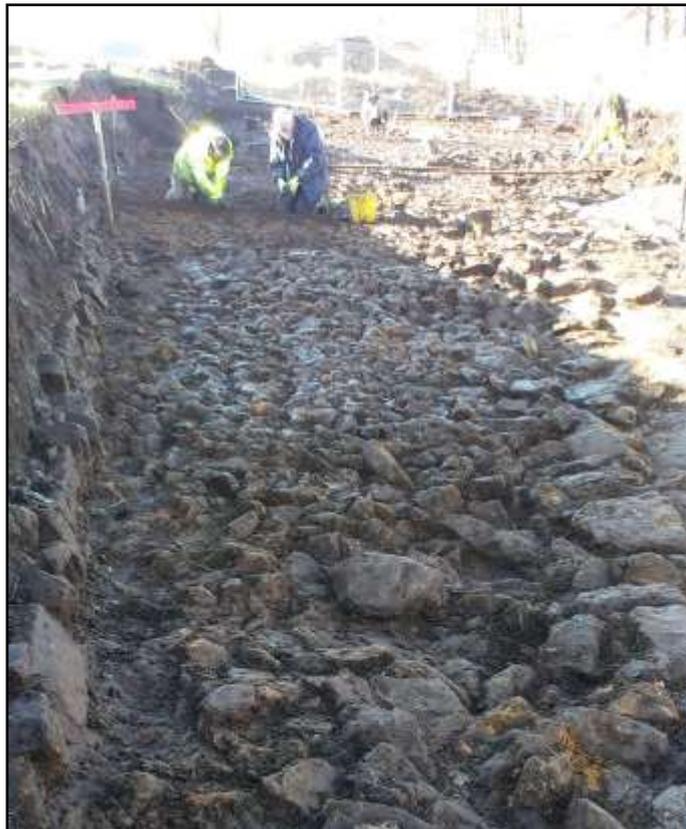
Further cleaning reveals the quality of the road surface

The principal feature was a cobble road aligned ENE-WSW, running at an oblique angle to the carriageway of the B6318 "Military Road" and extending over a distance of 37m to the western end of the site. This included a kerb of glacial boulders and sandstone slabs which formed the northern edge of the road, with a surface comprising small sandstone cobbling and sandstone slabs laid flat. No evidence of a kerb was observed on the south side of the road. Some 2nd or 3rd century pottery and tile on the excavated surface and, in places, wedged between the stones, though none to provide

a date for the construction of the road. The absence of post Roman pottery on the surface and its relationship to features in the landscape suggest a Roman date for the newly discovered road.

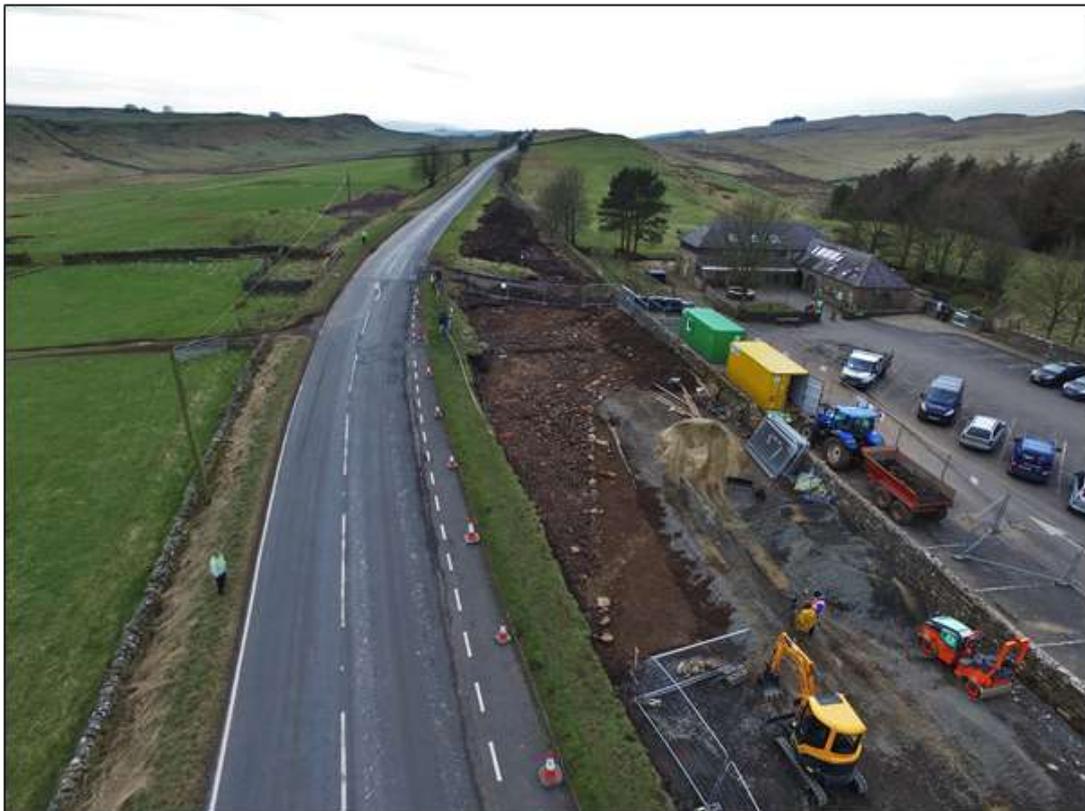
The site viewed from the air adjacent and underneath the 18th century military road
